E Canal wasteway. Location of proposed rehabilitation project.

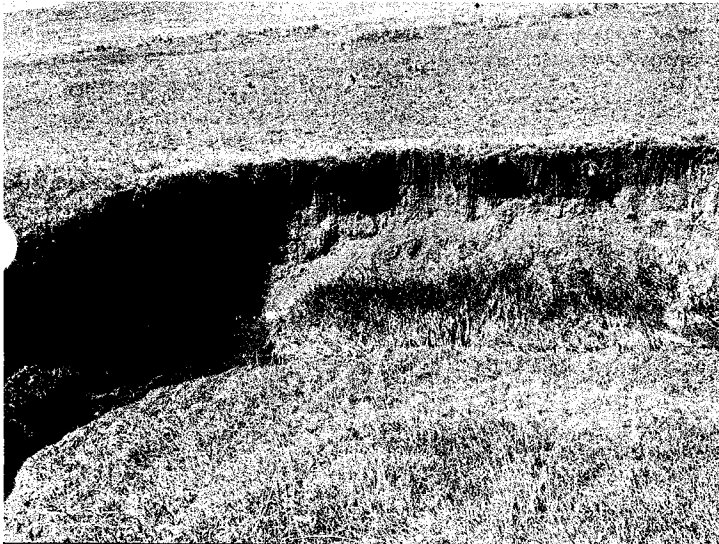
Bank erosion within the E canal wasteway channel.

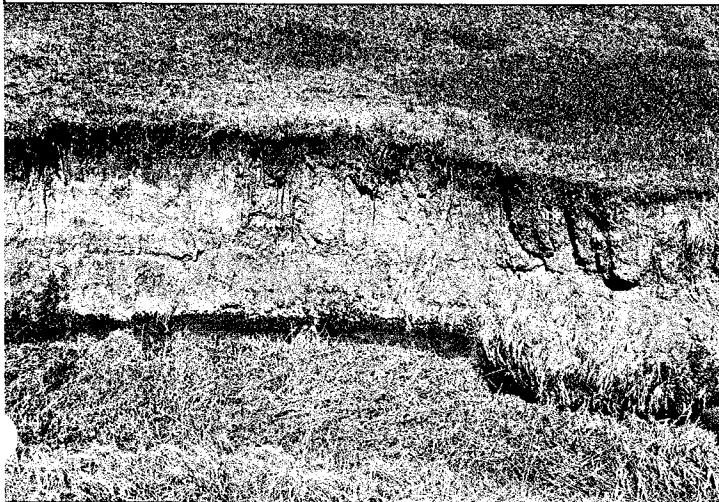
Bank erosion and salinity problems within the E canal wasteway channel.

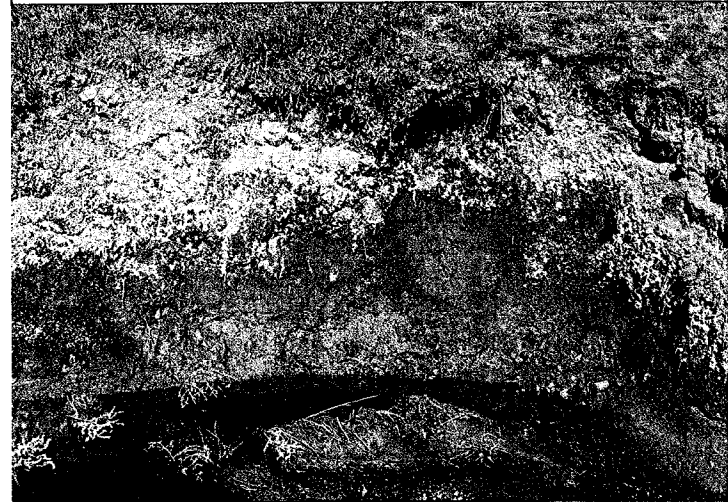
Bank erosion and salinity problems within the E canal wasteway channel.

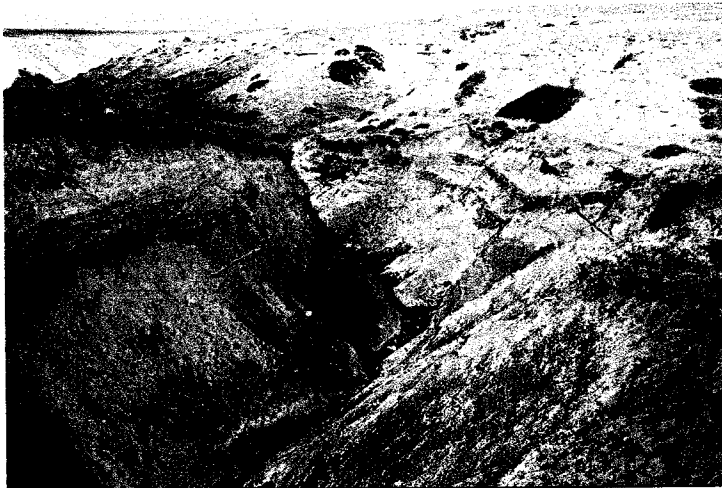
Severe bank erosion in AN canal wasteway estimated 46,000 tons of sediment into the Marias R.

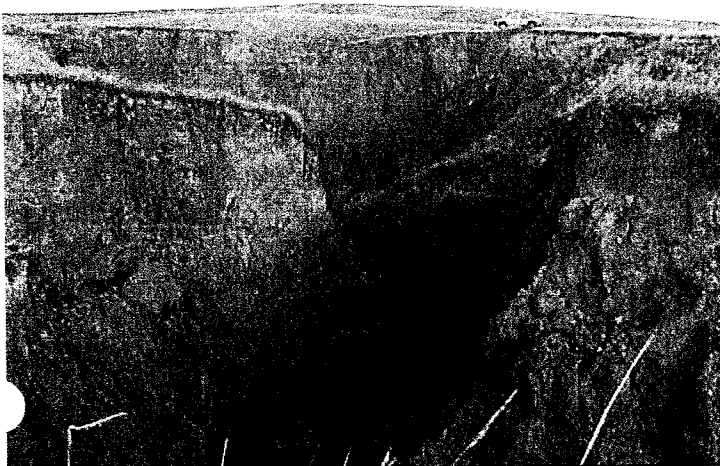
Severe bank erosion within the K wasteway channel.

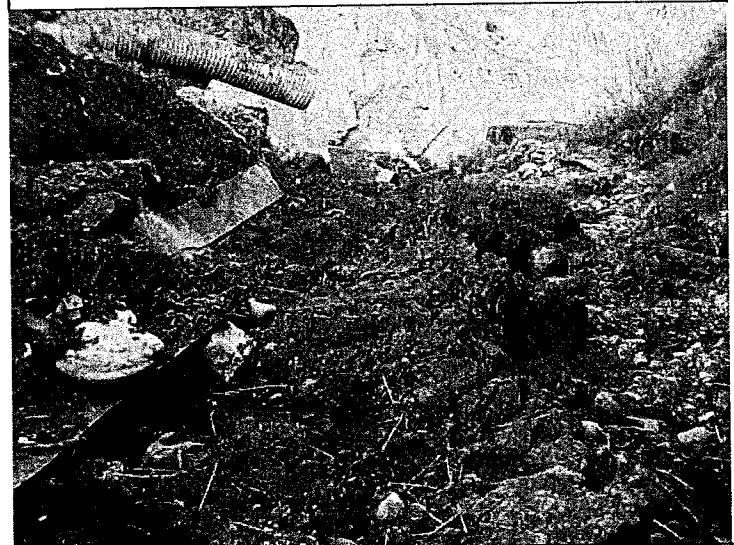
Severe bank erosion within the K wasteway channel.
